## Accreditation Clinical Case Report, Case Type I: Six or More Indirect Restorations (Failed)

by John Highsmith, D.D.S., D.I.C.O.I.

## Lessons Learned from John Highsmith, D.D.S., D.I.C.O.I. ( Failed Case)

## Accreditation Case Report, Case Type I: Six or More Indirect Restorations

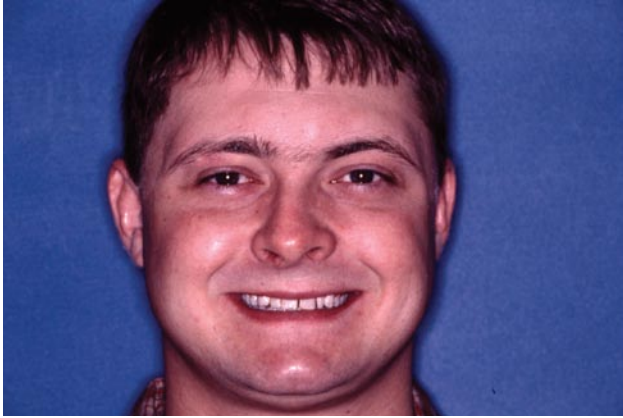
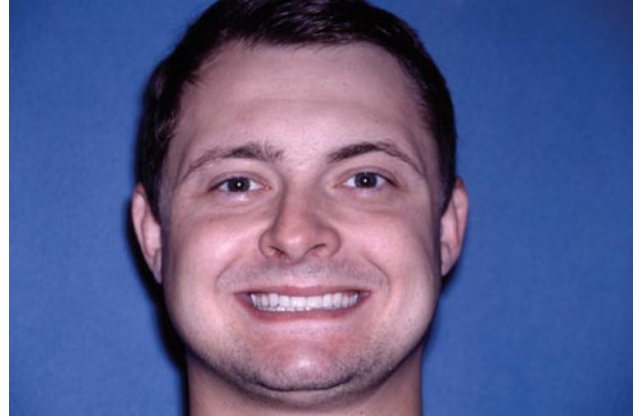
Figure 1: Full face, before and after.

A 31-year-old male wished to improve his smile. He presented with several diastemas, a peg lateral, and an unusual mottling of the enamel surface, possibly from fluorosis (Figs 1 & 2).

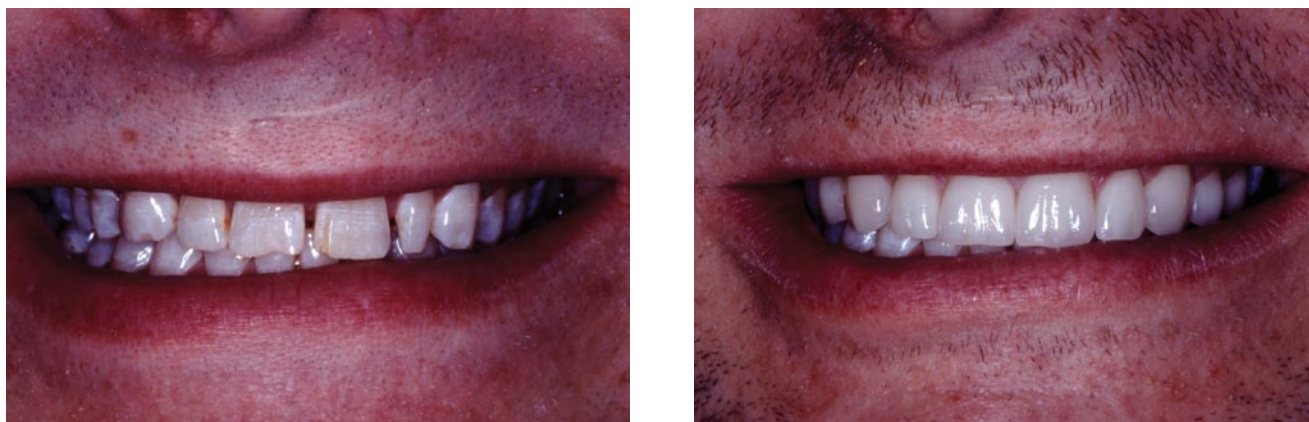
Figure 2: Unretracted smile, before and after.

While the midline appears straight on the retracted views, looking back on the case, the unretracted views do give the appearance of a cant. This illustrates the importance of choosing a case that has the possibility of an ideal result. The more challenges not under your control, the smaller your margin for error in the case.

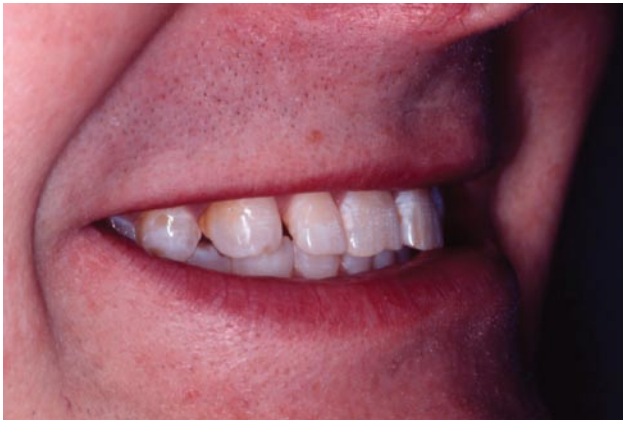
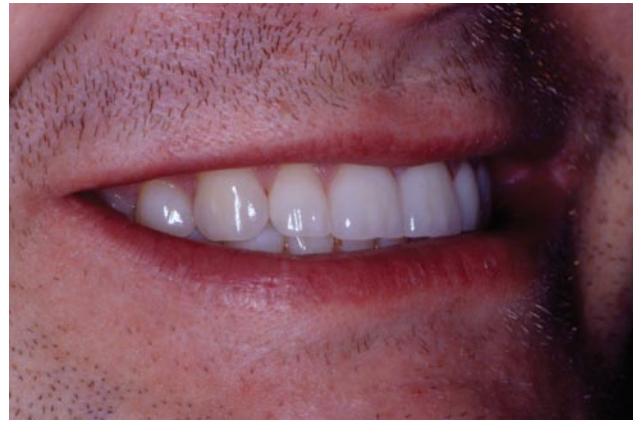
Figure 3: Unretracted lateral smile, before and after.

0-1 ingot), or required more than a 3-mm thickness of porcelain.<sup>2</sup> Only one coat of die spacer was used in the laboratory, to ensure that the porcelain-to-composite ratio was greater than 3:1, in order to avoid cracks due to the different coefficients of thermal expansion of porcelain and composite resin.<sup>3</sup> Thick composite under a feldspathic veneer makes it more likely to crack. The patient chosen shade B-1. The cuspids were made a half-shade darker at their gingival aspect for a more natural appearance (Figs 3 & 4).

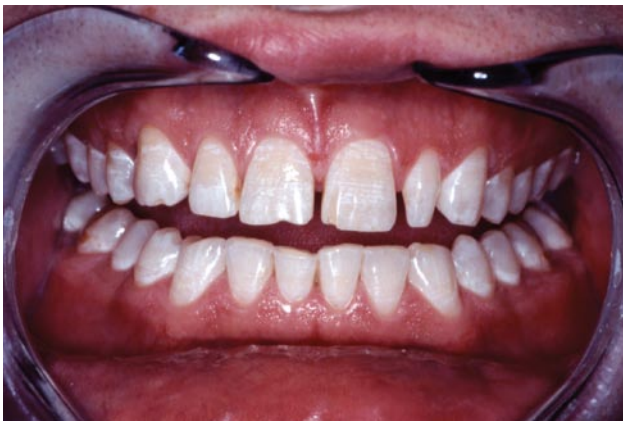
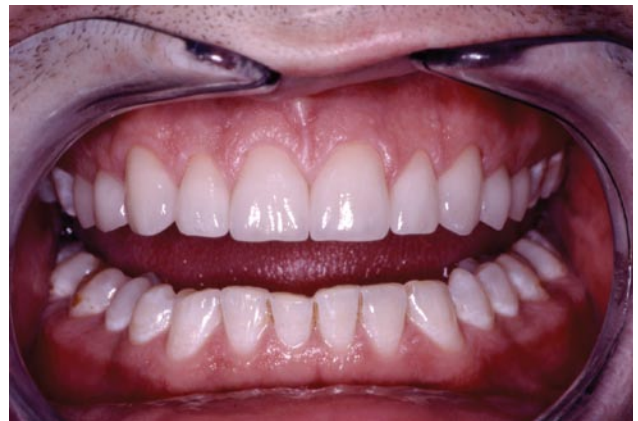
Figure 4: Retracted 1:2 frontal, before and after.

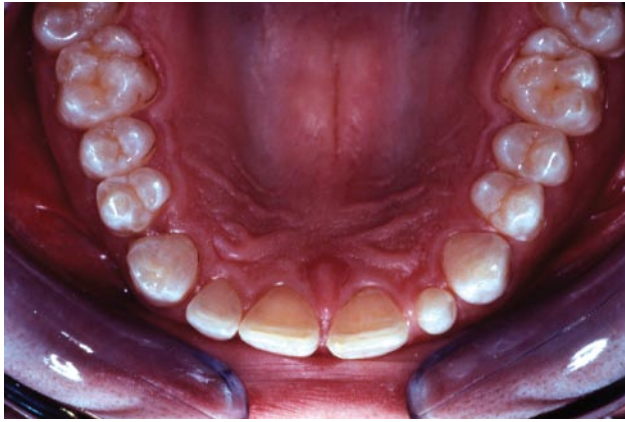
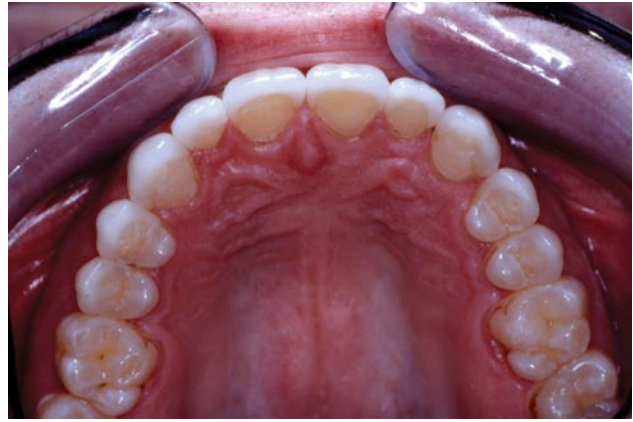
*Figure 5: Occlusals, before and after.*

intraoral polishing kit. Any interproximal roughness was smoothed with finishing and polishing strips. Anterior guidance was carefully adjusted to smooth group function in protrusive and shallow cuspid rise (Figs 5 & 6).

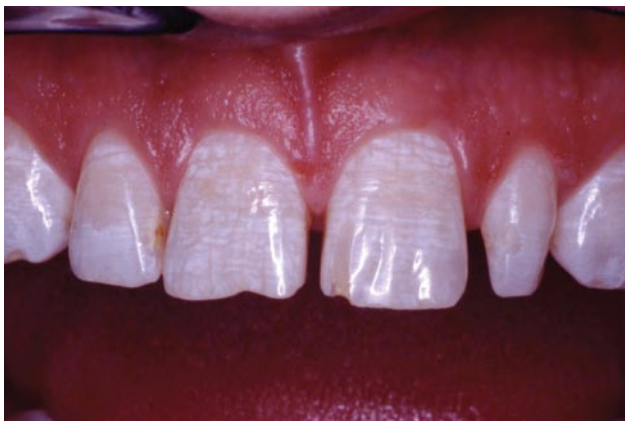
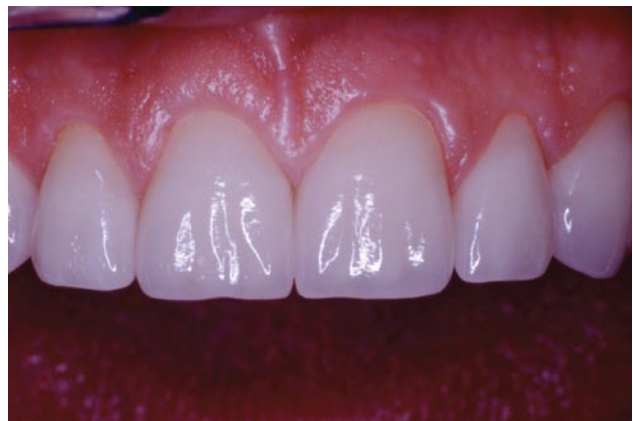
*Figure 6: 1:1 frontal before and after.*

Margins are visible on the 1:1 view, and there appears to be a short margin on one of the radiographs. (Yes, the examiners do look at the films!)

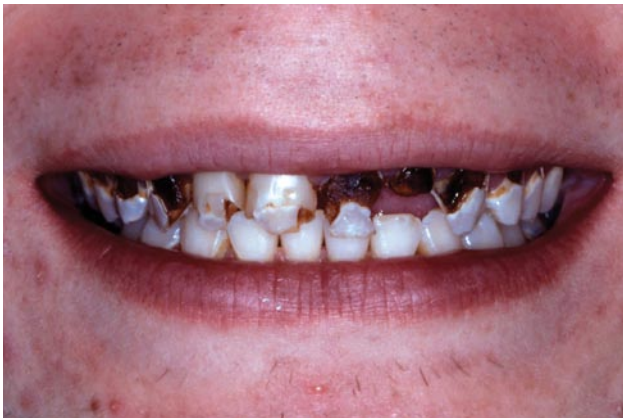
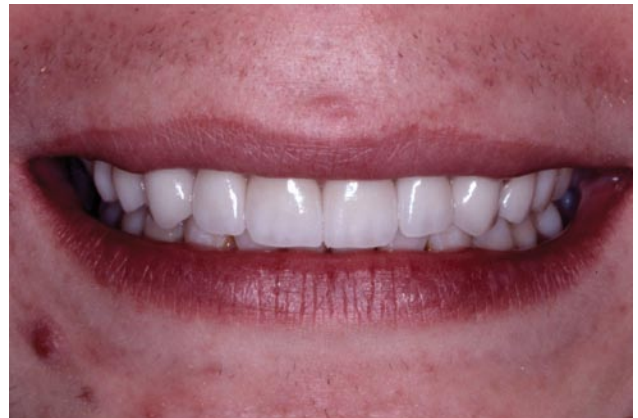
*Figure 2: The shape and shade of the final restorations harmonize and blend within the framework of his smile.*

The cosmetic dentist is faced with a wide array of challenges, ranging from the patient who wishes to change an acceptable smile to an outstanding smile; to the other end of the spectrum, wherein a patient is faced with a severe esthetic deformity such that smiling is simply not an option. The loss of self-esteem due to an inability to smile confidently can rival function and comfort concerns in severity<sup>1,2</sup> (Figs 1 & 2).

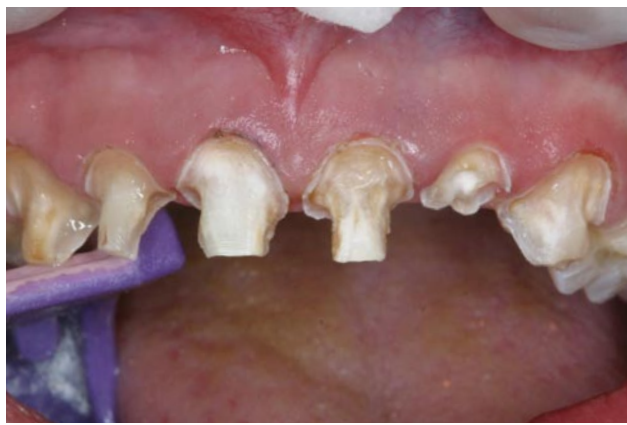
Figure 3: Digital photograph with a level reference plane allows better visualization of gingival levels.

A photograph with a horizontal reference was taken to ensure even tissue heights (Fig 4). Any area of subgingival margin was exposed with a laser, and a full arch impression was

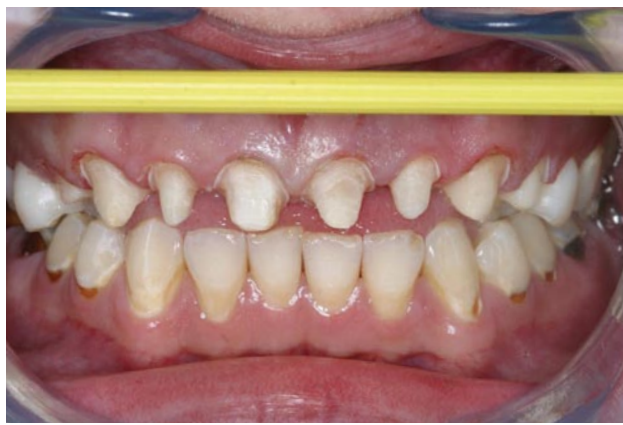
Figure 4: All caries removed, before core build-ups.

After plaque control instruction and prophylaxis, the patient was scheduled for tooth preparation. All carious tooth structure was removed with round burs from teeth ##3–15 (Fig 3). Inadequate tooth structure for retention of porcelain was noted on tooth #7. Endodontics

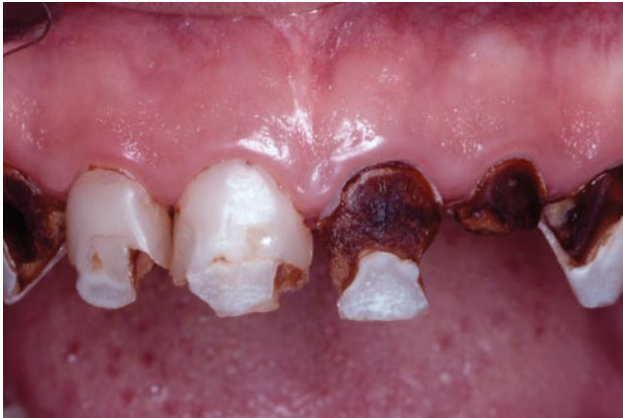
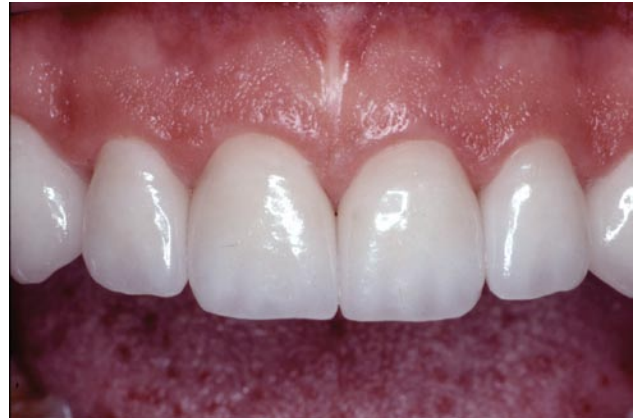
*Figure 5: Healthy gingival tissues result from proper adaptation of the porcelain margins and excellent home care by the patient.*

Final photographs and radiographs were taken at a subsequent appointment after the tissue healed (Figs 5–7). The patient's home care has been meticulous, and the change

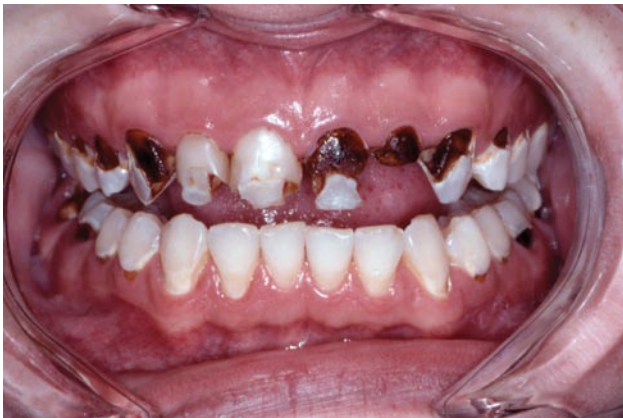
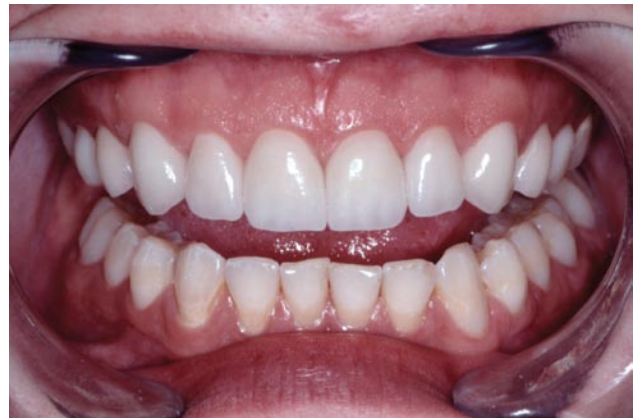
*Figure 6: The combination of acceptable gingival levels and suitable intra arch tooth position gave the restorative dentist greater control in creating an ideal final result.*

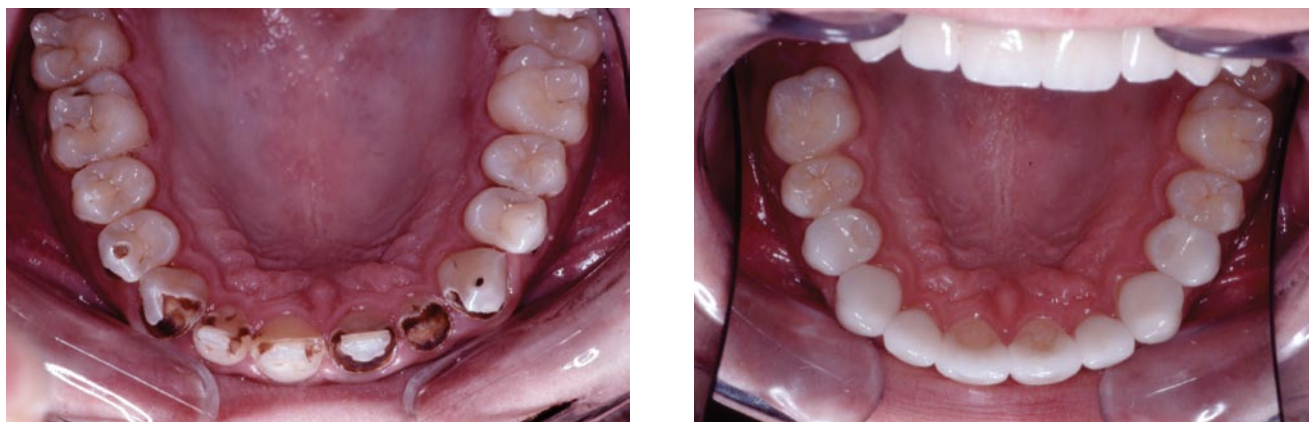
Figure 7: Open and symmetrical facial embrasures.
